Norton St Philip Footpath Report – May 2024

Norton St Philip Footpath Report – Detail Appendix

FR11/7 and FR11/8 – Status RED (Footpaths from Vicarage and Mackley Lanes)

FR11/19 – Status AMBER (Footpath leading from Norwood Farm to Sparkey's bungalow)

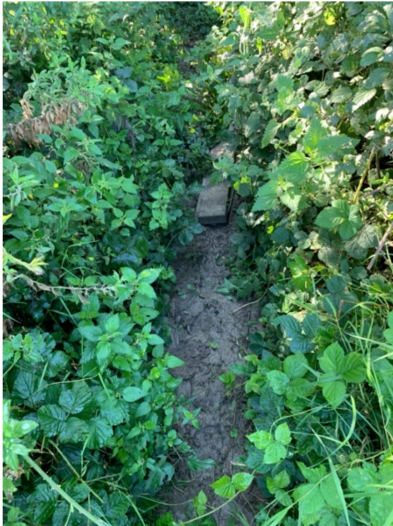
The approach (from the direction of NSP) to stile #34530 is boggy even in summer, the ground is also very uneven and therefore treacherous in winter months.

It can be seen that someone has attempted to improve the situation by placing a plank of wood, but this is unstable and could in itself become a hazard.

The footplate on the stile is broken, which makes it more difficult to negotiate.

Improvements are required.

This needs to be repaired or preferably replaced with a gate.

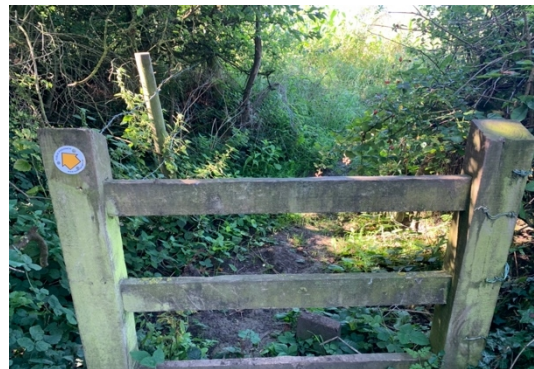
The waymark points diagonally across the field in accordance with the Definitive Map, which shows FR11/7 converging with FR11/8 (coming from Mackley Lane) in the middle of the field, and continuing as FR11/8. Older maps show the field as three smaller bounded fields and in this context the convergence makes sense. However, the trodden path for the continuation of FR11/7 has in recent years been along the western hedge-line leading directly to a stile on the other side of the field. This arrangement appears to have been acceptable to both the landowner and footpath users.

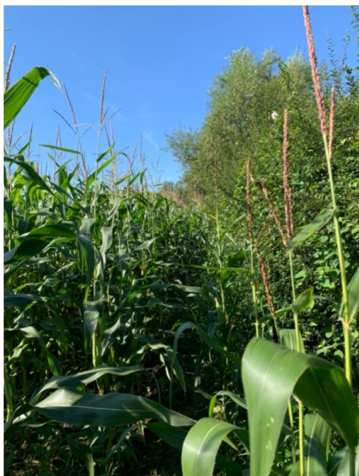
However, in 2023 the field has been planted with maize up to the hedge-line and combined with the hedge growth during the summer, the previously trodden path has been completely lost.

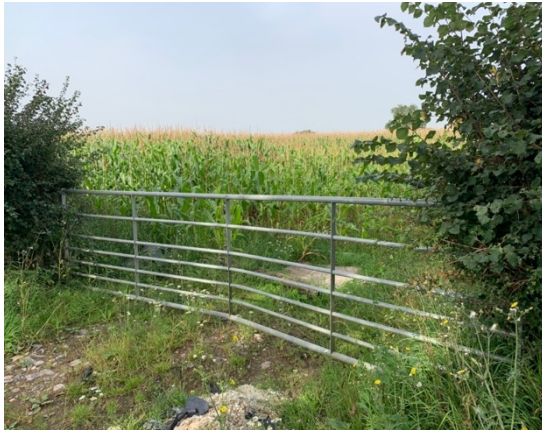
The section of FR11/8 running diagonally across the field from Mackley Lane is also completely compromised.

There is no signage to indicate the start of FR11/8 on Mackley Lane and the field gate is padlocked.

The route of the path is obliterated by the maize crop.

The landowner should be approached to request that footpaths be reinstated and maintained in future, with the possibility of re-routing FR11/8 along the northern edge of the field to join FR11/7 in the northwest corner, with FR11/7 then running along the western field edge, as has been the case recently.

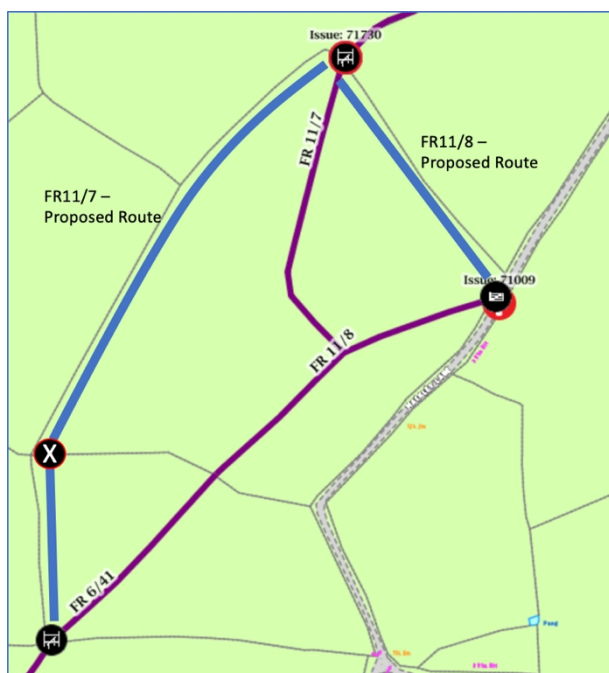
Purple lines show the existing footpaths per the Definitive Map. These were defined when the field comprised three smaller bounded areas.

The field has been completely cropped with maize in 2023 and the paths as shown are impassable.

Blue lines indicate proposed routes around field edges. The proposed route of FR11/7 has been the trodden path in recent years and a stile already exists at position X.

(The path crosses into Hemington parish at position X and becomes FR6/41. This path has also followed the proposed route in recent years)

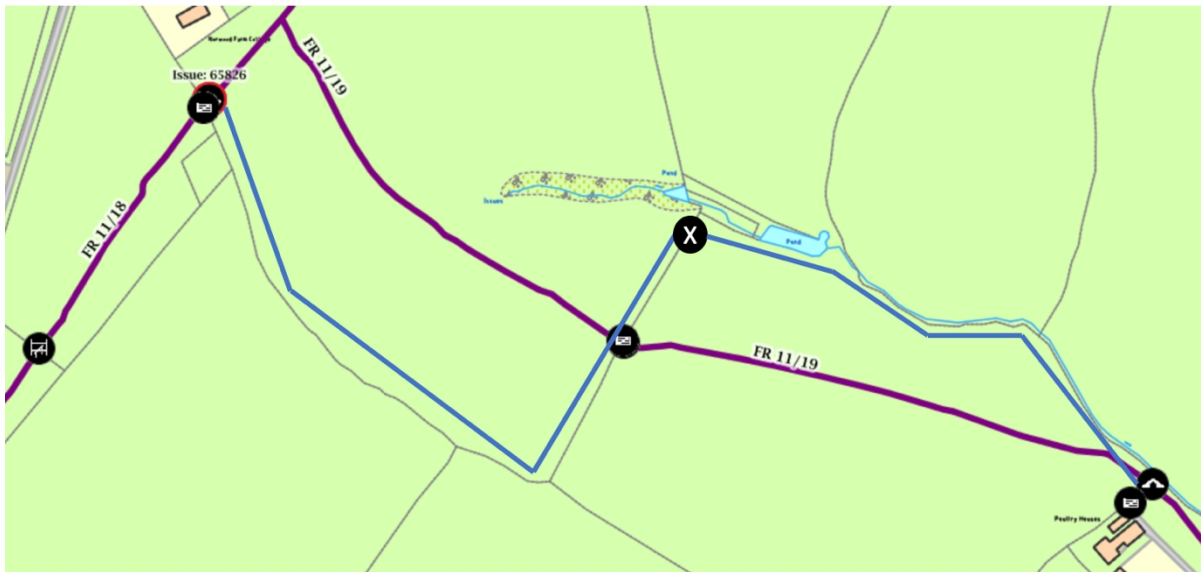
The line of FR11/19 per the definitive map is shown in purple.

The suggested alternative line is shown in blue.

The first section around the edge of the field is an established gravelled track as far as the field gate illustrated, and provides an existing and sensible alternative to the line shown on the definitive map. This is effectively already the trodden path as there is no discernible path on the line of the definitive map, and the field is often protected by an electrified(?) fence.

At the field gate the path passes through an area which in winter months is often extremely muddy and slippery, caused by cattle churning up the ground by the gate.

To avoid this muddy area, it would be possible with agreement to continue the path along to the corner of the field, install a pedestrian gate at position X and sign the footpath along the edge of the next field. The terrain here is pleasant, overlooking an area of bushes and ponds, and would potentially be preferable to the current line for both walker and landowner.
